Damage from lava flows: insights from the 2014–2015 eruption of Fogo, Cape Verde

S. F. Jenkins^{1,2*}, S. J. Day³, B. V. E. Faria⁴ and J. F. B. D. Fonseca⁵

Abstract

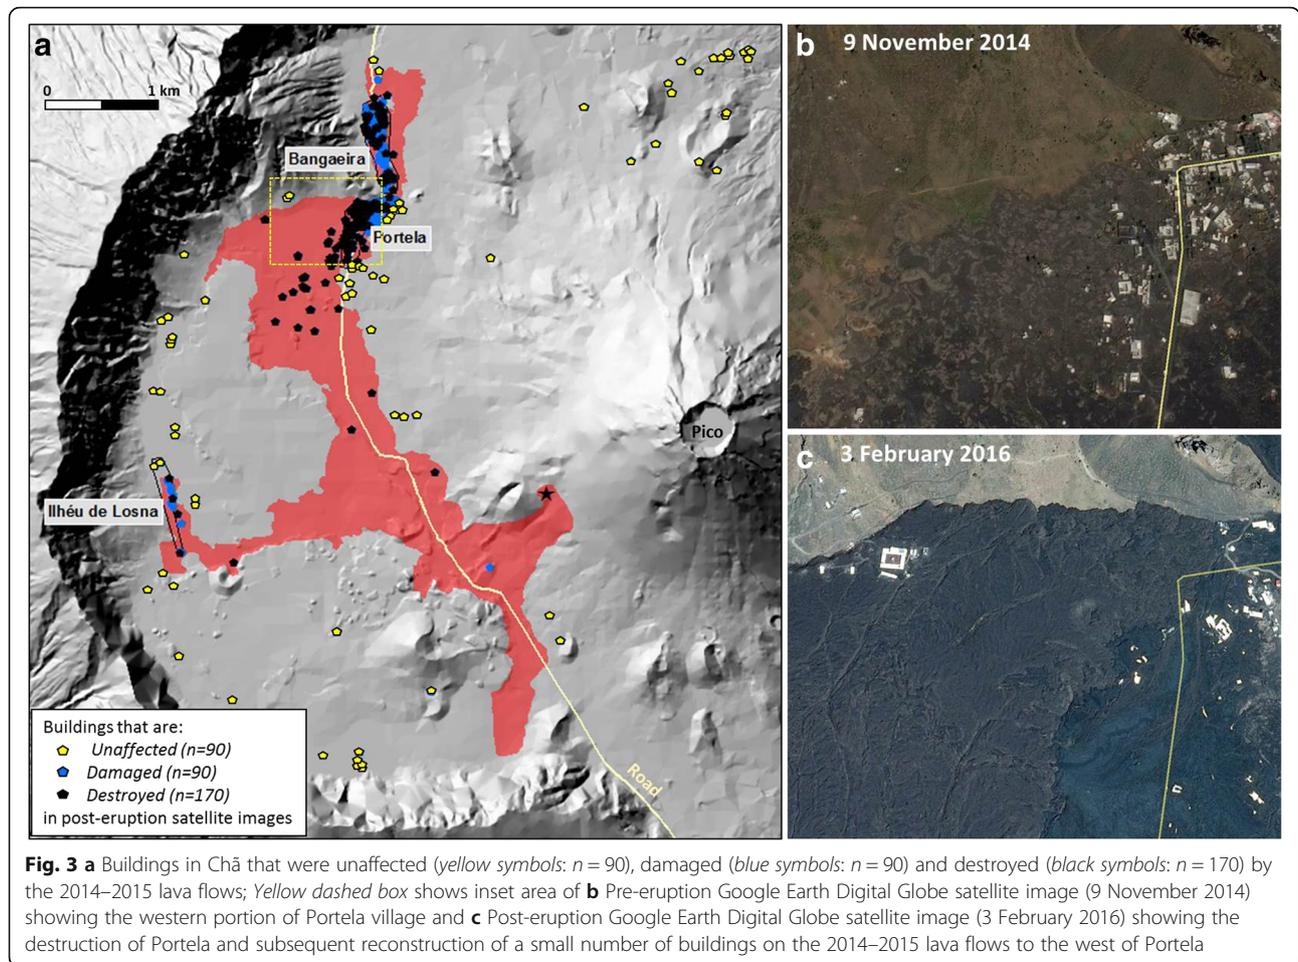
Of the approximately 350 buildings in Chã das Caldeiras, around 260 were in areas covered by lava flows during the 2014–2015 eruption (Fig. 3). Approximately 85% ($n = 210$) of the affected buildings were concentrated within the main villages of Portela and Bangaeira to the northwest of the vents, with a further 5% (10–15 buildings) in the small village of Ilhéu de Losna, due west of the vents. Fig. 3 shows the distribution of destroyed, damaged and unaffected buildings in Chã. The majority ($n = 170$) of the 260 affected buildings were completely destroyed and/or

buried by the advancing flow. Destroyed buildings were particularly concentrated in the southwestern parts of Portela (Fig. 3), which was covered by the main ‘a’ā flow that had a flow front up to several metres high.

Damaged buildings ($n = 90$; Fig. 3) were not limited to the periphery of flows and showed varying degrees of damage when visited on the ground. We observed four main modes of damage that were difficult to distinguish from each other in the remote assessment of satellite images, but that could be seen in the field, as described below.

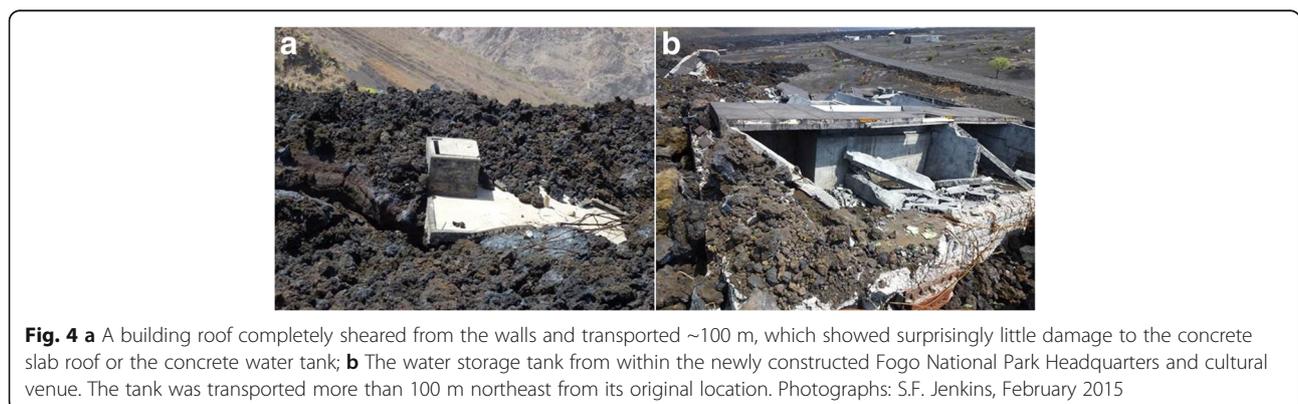
Of the destroyed buildings, a small number also had parts of the building transported within the flows. Such components were typically slab reinforced concrete. For example, a number of reinforced concrete roofs were

sheared from building walls by the flow and transported within the flow, some for many tens of metres (Fig. 4a). In at least fifteen cases, the roof sheared cleanly from the walls along the connection between the two, and in a further seven observed instances the wall was broken along the mortar-block interface. Household concrete water tanks in particular were observed to remain relatively intact when transported within the flow. The most

impressive example was that of a water storage tank from within the Park Headquarters, which was transported more than 100 m from its original location by the lava flows (Fig. 4b). While the building suffered damage to the roofing, walls and support beams, the overall structural envelope remained relatively intact. The remainder of the Park Headquarters was destroyed and the debris buried, although media images and reports and satellite images from the 25 November show that the flow was at first redirected around the oblique walls, before the south wall failed and flows inundated the building, entering and exiting through large existing openings.

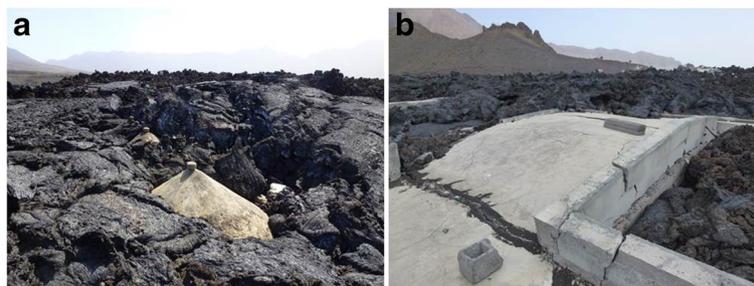
In the more eastern portions of Portela and in Bangaeira, where the pāhoehoe and rubbly ‘a‘ā flows had fronts of only 2 to 3 m high, many buildings were simply inundated by lava with the structure remaining relatively intact and in situ (Fig. 3). For buildings with strong, or very few openings, such as the traditional, cylindrical scoria buildings characteristic of Fogo, partial burial was common (Fig. 5a) and, where visible, the structure did not seem to be obviously damaged. ‘A‘ā flows entering through smaller openings and into buildings was limited and consisted of scoria fall from a flow outside the entrance, rather than flow ingress; pāhoehoe flows by contrast were able to flow through relatively thin openings like doors and windows. Multiple and weaker openings often permitted ingress of both types of lava flow into, or through, a building. Despite the lack of structural damage in some cases, these buildings were left uninhabitable and of limited value to the owners. Where lava flows had

entered a building through an opening, diagonal fractures from each opening corner radiated outwards along the mortar-block interface. In some instances, where lava flows reached a great enough thickness, ingress caused doming of reinforced concrete slab roofs (Fig. 5b).

Fig. 5 **a** Burial of a traditionally-constructed community centre in Portela, which comprised semi-circular scoria walls up to 40 cm thick, with few openings; **b** Doming of a reinforced concrete slab roof within Portela: the building envelope remained relatively intact but lava flows inundated all of the building footprint to approximately roof height. Photographs: S.F. Jenkins, February 2015

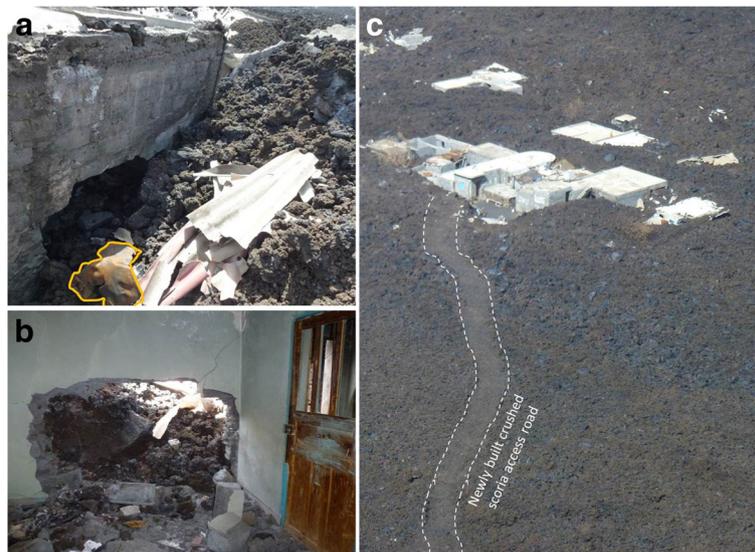
may have allowed the water to seep out gradually. Only one example of the explosion of a gas canister was observed (Fig. 6a and b). The explosion punctured a large hole in the wall of an otherwise intact building isolated within the lava flow.

Fig. 6 **a** The explosion of a gas canister used for cooking (oxidised remains highlighted in orange in lower middle of photo), presumably as a result of proximity with the lava flow, **b** punctured a large hole in the side of this squared masonry building (photo taken inside building); The building remained otherwise intact; **c** A building in Bangaeira that was not inundated or destroyed by the surrounding lava flow but was left isolated within the flow. By the time of our visit, approximately 11 weeks after impact, a road had been prepared to allow the family to return and people and donkeys to transport provisions to the building. Photographs: S.F. Jenkins, February 2015
