Remotely assessing tephra fall building damage and vulnerability: Kelud Volcano, Indonesia

George T. Williams^{1,2*}

Keywords: Damage survey, Remote sensing, Vulnerability functions, Volcanic ash, Structures, Kelud 2014 eruption

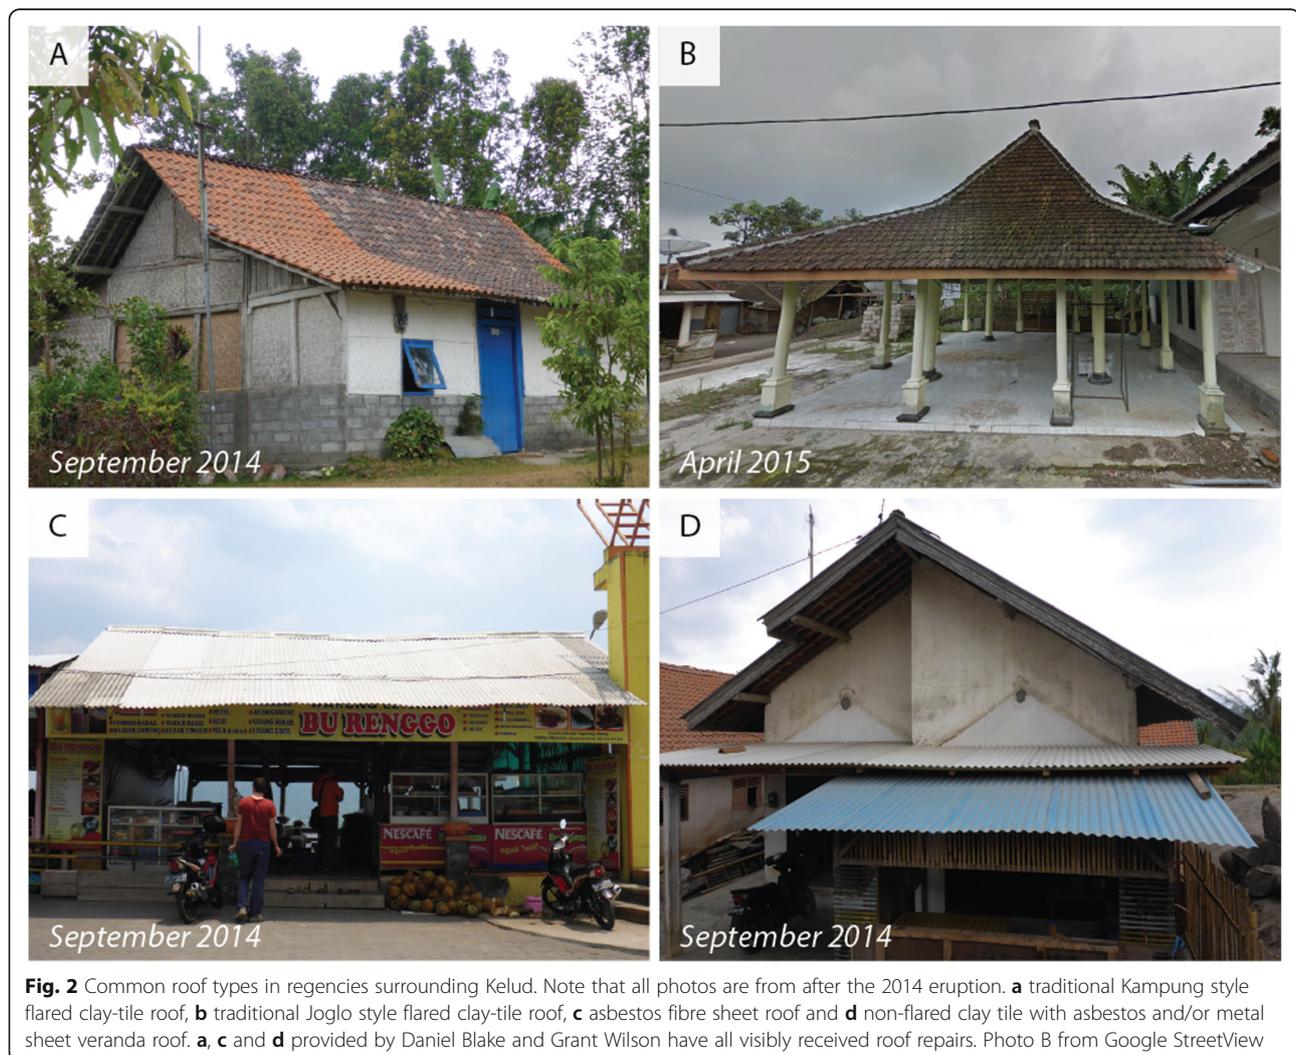
Fig. 2 Common roof types in regencies surrounding Kelud. Note that all photos are from after the 2014 eruption. **a** traditional Kampung style flared clay-tile roof, **b** traditional Joglo style flared clay-tile roof, **c** asbestos fibre sheet roof and **d** non-flared clay tile with asbestos and/or metal sheet veranda roof. **a**, **c** and **d** provided by Daniel Blake and Grant Wilson have all visibly received roof repairs. Photo B from Google StreetView

popular form of construction for livestock shelters and small shops (e.g. Fig. 2c). As sheet roofs are lighter than tiled roofs and do not require timber battens, the spacing between framing members is typically wider for sheet roofs and therefore, they are potentially more prone to collapse under tephra fall loading (Spence et al., 1996; Blake et al., 2015).

pre-eruption would often have a slight but noticeably lighter appearance after the eruption (e.g. Fig. 2C). Again, we interpret this as replacement of old, damaged or collapsed asbestos fibre sheets based on limited ground-truthing using media images and observations from Blake et al. (2015). These colour changes were used to infer the extent of repairs that were carried out after the eruption, as a proxy for damage. Commonly observed

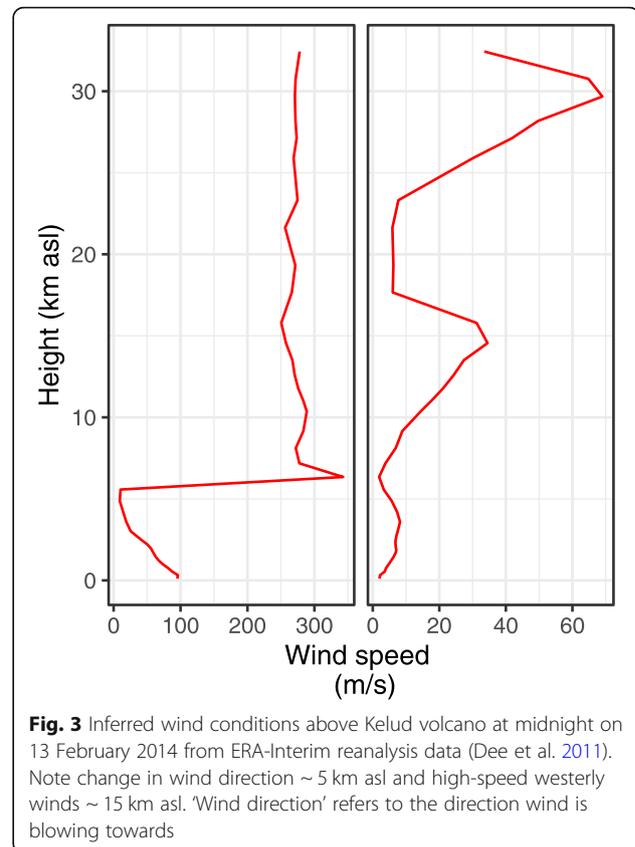
Fig. 3 Inferred wind conditions above Kelud volcano at midnight on 13 February 2014 from ERA-Interim reanalysis data (Dee et al. 2011). Note change in wind direction ~ 5 km asl and high-speed westerly winds ~ 15 km asl. 'Wind direction' refers to the direction wind is blowing towards

Thickness measurements were inverted using the Tephra2 algorithm of Connor and Connor (2006) to estimate the eruption source parameters (ESP; e.g. plume height, tephra mass, total grain-size distribution) and empirical parameters (e.g. fall-time threshold and diffusion coefficient, see Bonadonna et al. (2005) and Biass et al. (2016)) that best reproduce observed measurements. Wind conditions were fixed and inferred from the wind profile for midnight of 13 February 2014 obtained from the European Centre for Medium-Range Weather Forecasts (ECMWF) Era-Interim Reanalysis dataset, which is available at six-hourly intervals (Dee et al., 2011). As most tephra was erupted over four hours in one main phase that began half an hour before midnight, interpolation between two time periods (18:00 and 00:00) was deemed unnecessary, so dispersion modelling was carried out using the single wind profile of 00:00 (Fig. 3).

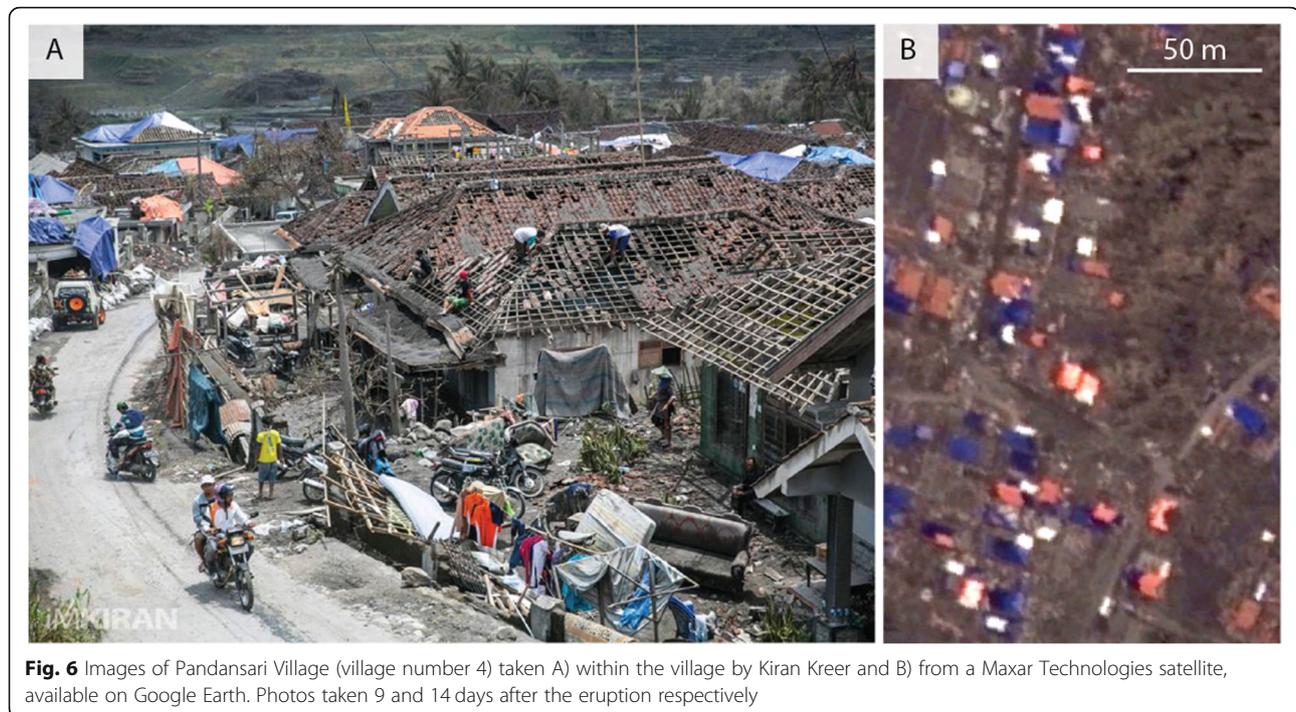
Fig. 6 Images of Pandansari Village (village number 4) taken A) within the village by Kiran Kreer and B) from a Maxar Technologies satellite, available on Google Earth. Photos taken 9 and 14 days after the eruption respectively

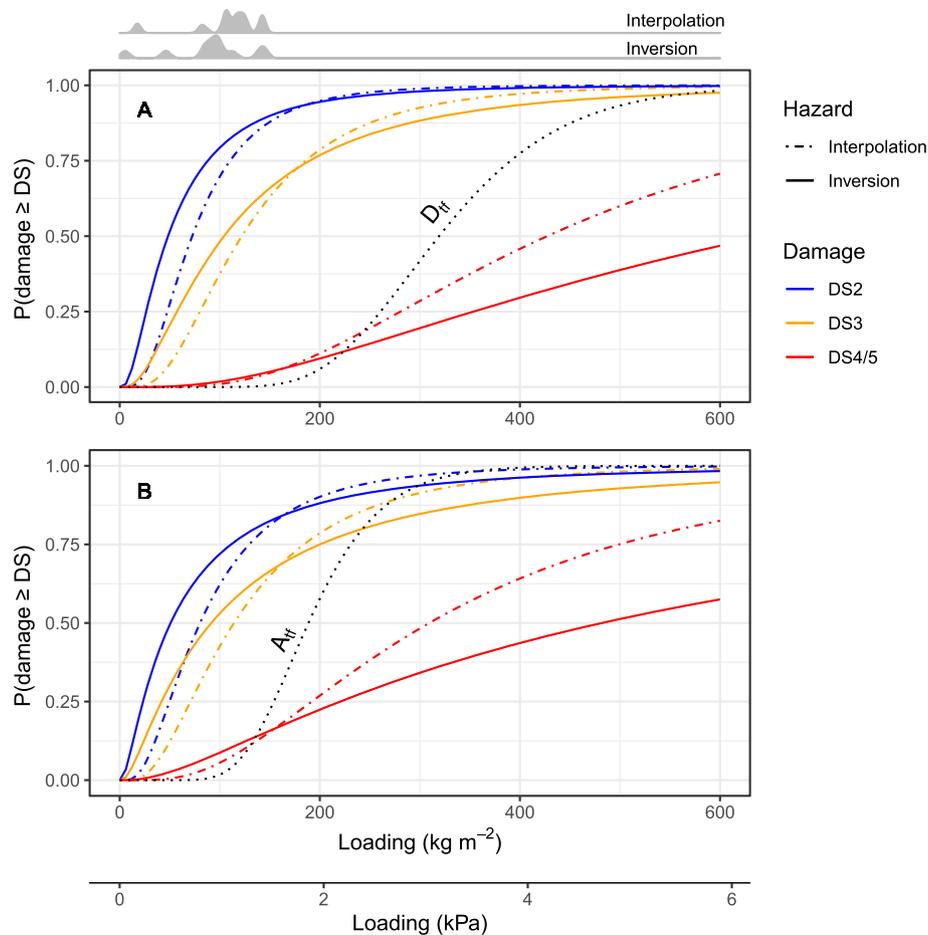
Fig. 9 Fragility curves fit using tephra loads from both hazard models for A) tiled roofs and B) grey roofs. Density plots show differing distributions of tephra loads across the 1154 buildings used to fit curves, and that all data are from hazard intensities below 200 kg m^{-2} . For comparison with published curves, the black dotted lines in A) and B) are the roof collapse curves for tiled and asbestos sheet roofs from Jenkins and Spence (2009). Their annotations, D_{tf} and A_{tf} , reflect the curve labels from that study. R script, Microsoft Excel spreadsheet and raw data to fit curves are available on Github (<https://github.com/flying-rock/kelud14>). Curve parameters given in the Appendix

For both recognised building types, two sets of fragility curves were fit, one for each hazard characterisation approach (Fig. 9). The curves were fit to data using a cumulative link model (CLM) and take the typical form of a log-normal cumulative density function used in the vast majority of published parametric fragility curves (Rossetto and Ioannou, 2018). A CLM is a type of generalised linear model that makes use of the ordinality of

At relatively low hazard intensities, the curves fit using hazard intensities derived from inversion model buildings as more vulnerable compared to curves fit using interpolation. Conversely, at relatively high hazard intensities $> 150 \text{ kg m}^{-2}$, the inversion curves model buildings as less vulnerable and they appear to unrealistically underestimate the likelihood of roof or building collapse (DS4/5). When comparing both DS4/5 curves to published fragility curves, the interpolated DS4/5 curves more closely approximate the two roof collapse curves from Jenkins and Spence (2009) that are likely to be most representative of buildings surrounding Kelud. These include tiled and asbestos roofs in ‘average to good condition’ (Fig. 9).
